# Analyzing Mortars and Stuccos at the College of Charleston: A Comprehensive Approach

DOROTHY S. KROTZER AND JOHN J. WALSH

**This article presents an overview of methodologies currently available for mortar analysis and a suggested approach.**

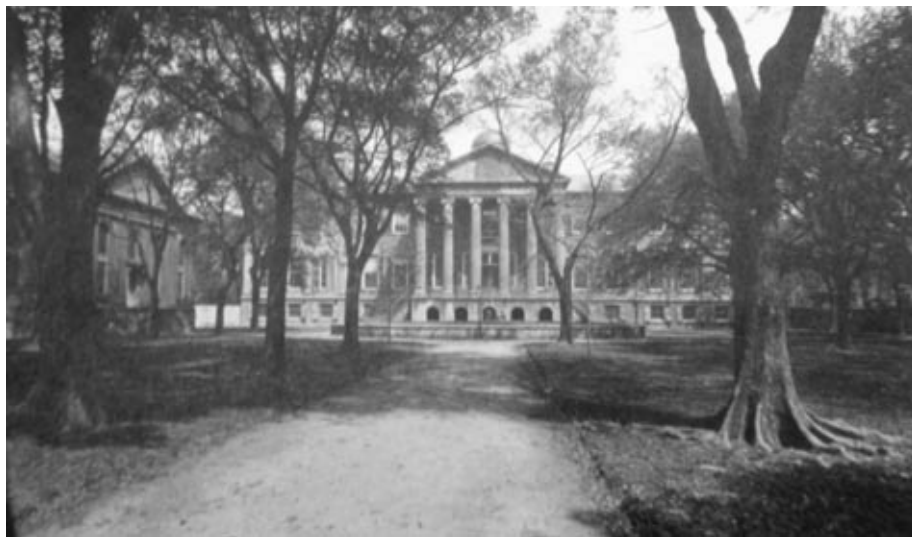
Fig. 1. This 1902 photograph of the Cistern area of the College of Charleston shows Randolph Hall, with Towell Library, built in 1858, to the left. Randolph Hall, originally designed by William Strickland and referred to simply as the Main Building, was begun in 1828. Photograph by William H. Jackson, published in Gene Waddell, *Charleston Architecture* (Charleston: Wyrick & Company, 2003).

been significantly modified through subsequent building campaigns.<sup>2</sup> The other two structures that comprise the Cistern area are Porter's Lodge, designed by Charleston architect Edward Brickell White and built in 1851, and Towell Library, designed in the Italian Renaissance Revival style by George Edward Walker and constructed in 1856.<sup>3</sup> All buildings are brick and stucco with stone trim (Fig. 1).

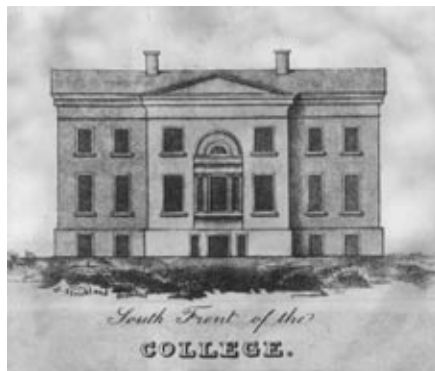
Fig. 2. William Strickland, design for Randolph Hall, 1828. Courtesy of Special Collections, College of Charleston Library.

Randolph Hall, as it exists today, is very different from Strickland's original design — a simple plan executed in the "Rational Neoclassical" style with no portico and no wings (Fig. 2). Although depicted as a stuccoed building in Strickland's 1828 sketch, historical documentation indicates that Randolph Hall was not actually stuccoed until the 1850s. Less than 25 years after its construction, architect E. B. White was asked to expand the building, resulting in a remodeling in the Italian Renaissance Revival style. White's new program, implemented in 1851, included the addition of a portico, changes to the doors and windows, and the addition of flanking wings with Ionic pilasters. The building was also first stuccoed at this time.<sup>4</sup>

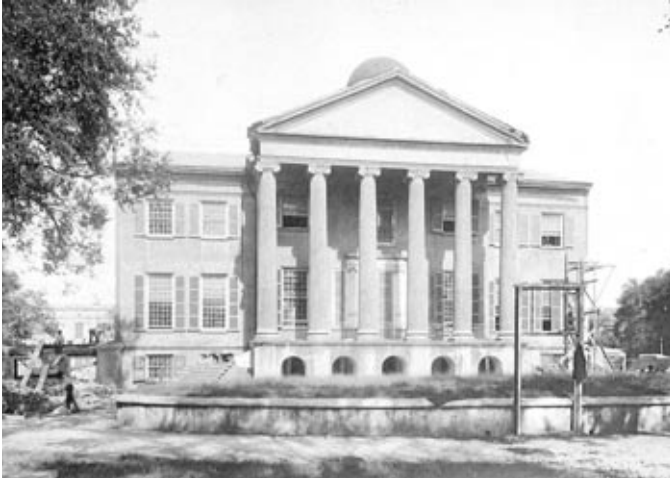
Fig. 3. Randolph Hall in 1887, following the Charleston earthquake. Note that the wings built in 1851 had to be completely removed but that the central portion of the building remained relatively unaffected. Photograph from George L. Cook, *Earthquake News*, No. 129, courtesy of Photographic Archives, South Caroliniana Library, University of South Carolina.

Thirty-five years after White's modifications, the Charleston earthquake of 1886 caused serious damage to Randolph Hall and required additional changes.<sup>5</sup> White's 1851 portico was damaged, and his wings had to be completely rebuilt, including the foundations. This work was overseen by one of Charleston's "gentleman architects," Dr. Gabriel Edward Manigault (Fig. 3). The wings were not rebuilt simultaneously.

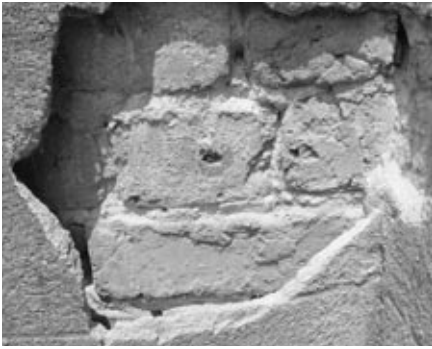
Fig. 5. Randolph Hall, area of bricks and mortar behind stucco that was exposed as part of testing. Samples of both mortar and stucco were removed from this location for laboratory analysis. Photograph by D. Krotzer.

Guided by the history of these buildings, samples of mortar and stucco were removed from key areas in order to document the materials used to construct each building (Fig. 5). Preliminary visual examination of brick-mortar samples suggested superficial similarities among materials used in the three buildings. Each of the mortars was pale yellow in color and very soft and friable and contained chunks of white lime particles visible to the naked eye. Laboratory analysis confirmed that three
